## Case study

### Investigation into the Failure of an FRP Vertical Cylindrical Tank

A glass fibre tank to be used for the treatment of waste water was supplied to a waste water treatment works in the UK. After installation, the tank developed a leak. It was repaired but continued to leak. The FRP vertical cylindrical tank for chemical storage use was designed to the following design criteria.

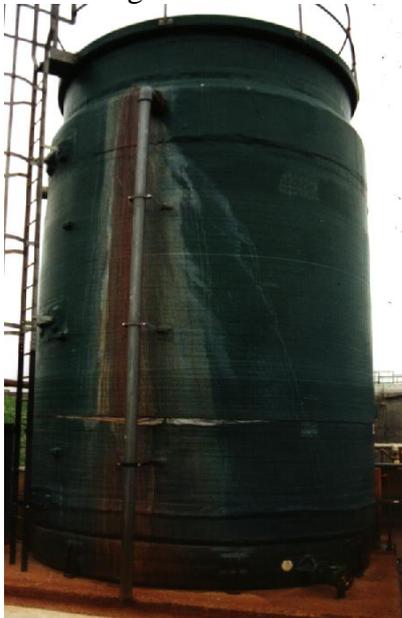
Fig 1 General view of vessel

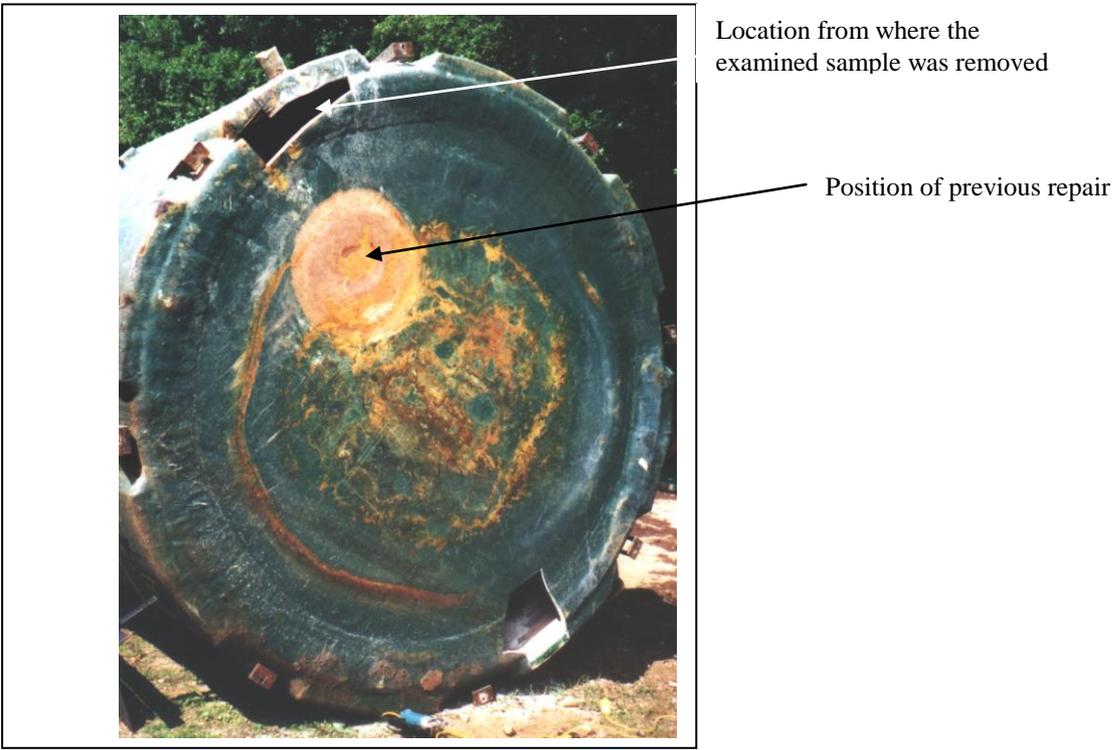
An area of the base of the tank approximately 600 mm diameter had been previously repaired. The repair laminate appeared sound and adequate. (The position of the repair is shown in Fig 2).

Fig 2 Vessel laid horizontally, general view of base.

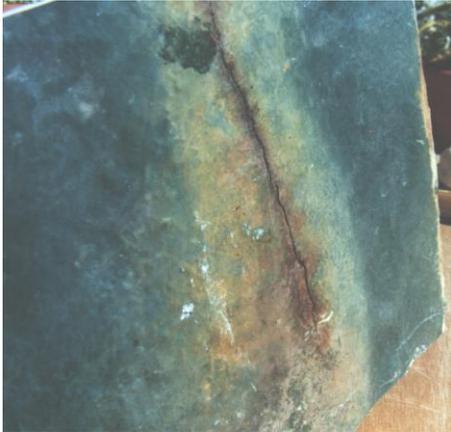
Fig 3 Exterior view of base of the tank

Two cracks could be clearly seen in the base. It was noted that they were diametrically opposed to one another and followed an approximate circumferential line within about 150 mm of the vessel wall. Sample laminates were machined from the area of the crack to allow closer inspection and analysis

Fig 3 shows the exterior view of base of the tank before being sectioned showing the extent of the crack. The crack was approximately 600mm long on the inside of the tank and 200mm long on the outside.

Bottom surface (external, in contact with the base) before being sectioned showing the extent of the crack.

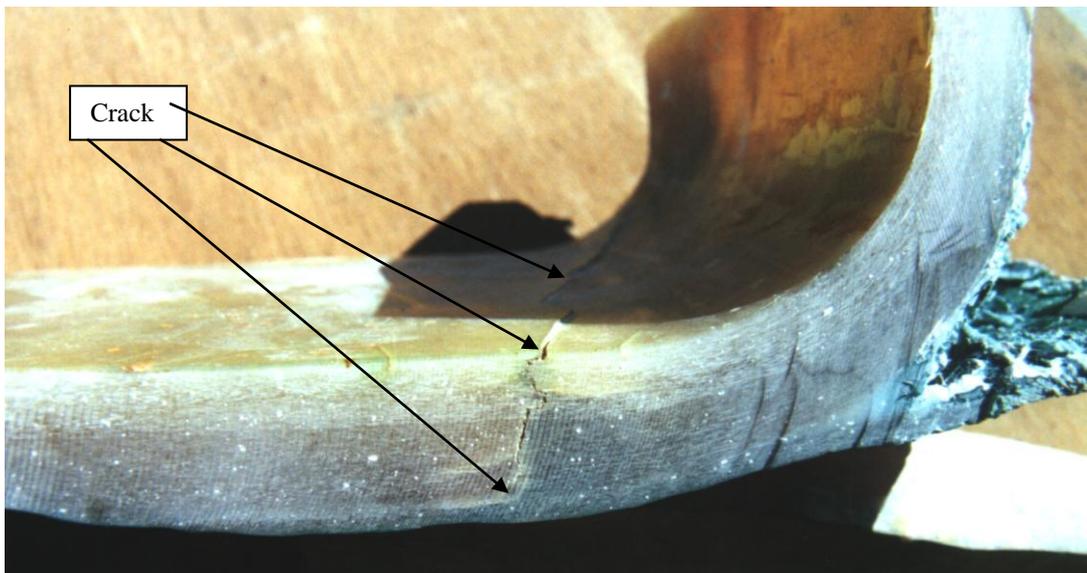
Fig 4 Examined sample – section through the base to wall knuckle radius.

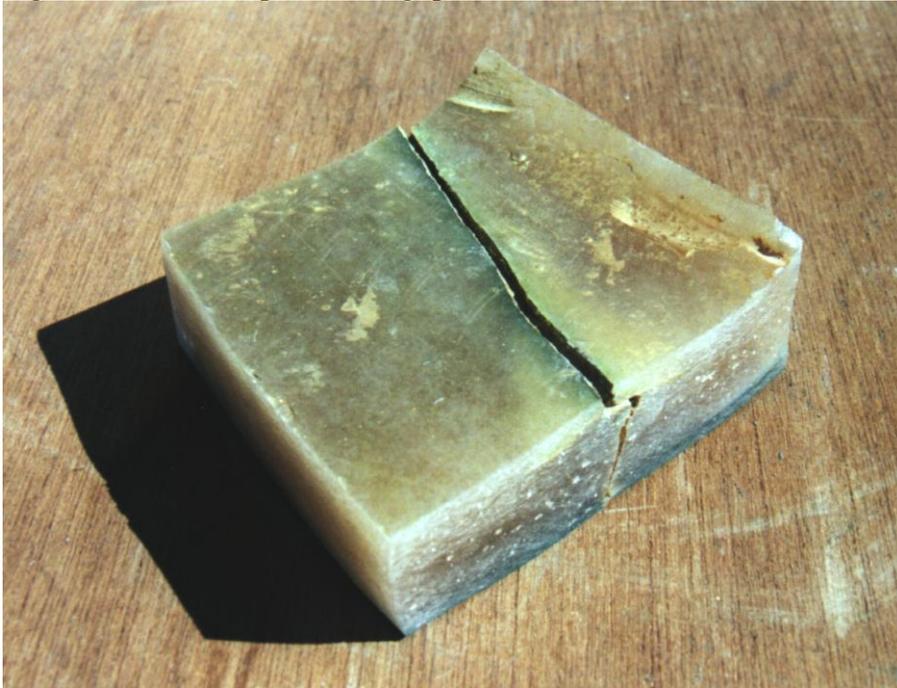
Fig 5 Removed sample showing part of the crack

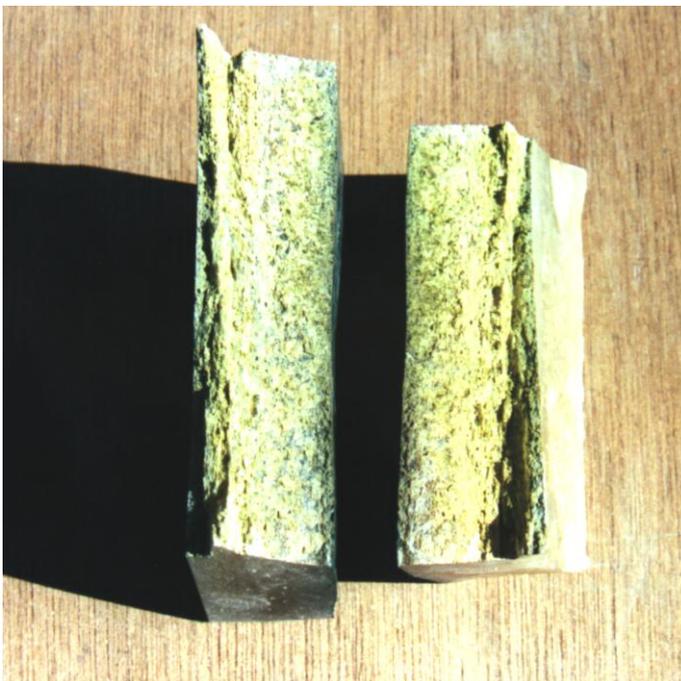
The sample was parted in two by hand, (an action which should have been impossible), to reveal the failure surfaces. They are shown in Fig 6. Inspection of this sample revealed two distinct zones (see Fig 7) one of which was fibrous and the other which was “rock” like, without any fibre protruding from the surface. The fibrous type surface is well known and to be expected from the failure of a random laminate. It was this material which was keeping the laminate together. It is apparent that the two failure types are significantly different.

Fig 6 showing both fracture surfaces

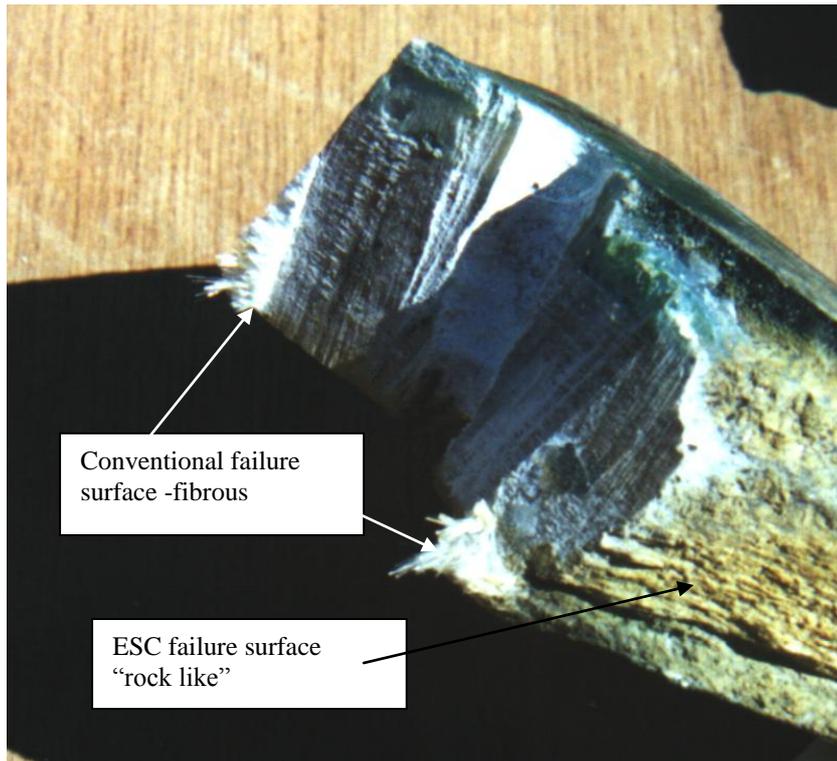
Fig 7 Contrast between the two types of failure showing the contrasting "fibrous" and "rock like" failure surfaces.

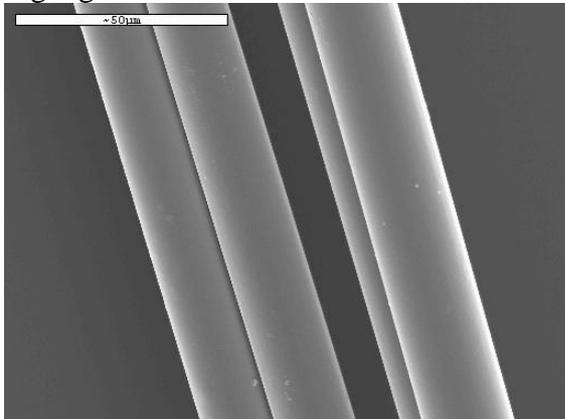
Fig 8 is an SEM micrograph of the surface of glass fibre (“E” glass) filaments before immersion. They are simple cylindrical objects devoid of features.

Fig 8 glass fibre filament before immersion

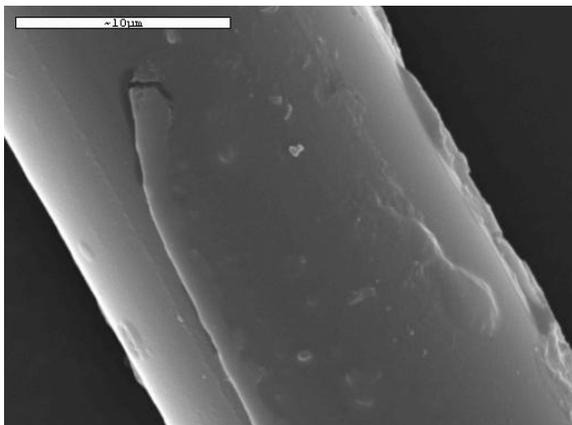
Fig 9 “E” glass filament (1000x) after 7 days immersion in Ferric Chloride solution

Fig 9 is an SEM micrograph of the surface of an individual glass fibre (“E” glass) filament which has been immersed in a sample of Ferric chloride solution for 7 days. (The sample of Ferric chloride solution was previously removed from the vessel). It can be seen that the filament has been attacked. It is apparent that it has been severely degraded by the effects of the Ferric chloride. A defect in the surface of a glass fibre has a catastrophic effect on its strength. We can conclude that a crack in the resin system which allows the Ferric chloride to gain access to the glass fibre reinforcement will attack the glass and prevent the normal crack stopping mechanism from operating. The crack will therefore continue to propagate through the laminate as long as the stress is applied and the aggressive environment has access to the reinforcement fibres.

Options available are, for instance, the use of gel coat and barrier layer resins with high strain to failure and or the use of one or more layers of synthetic veil or a corrosion resistant grade of glass fibre if necessary.

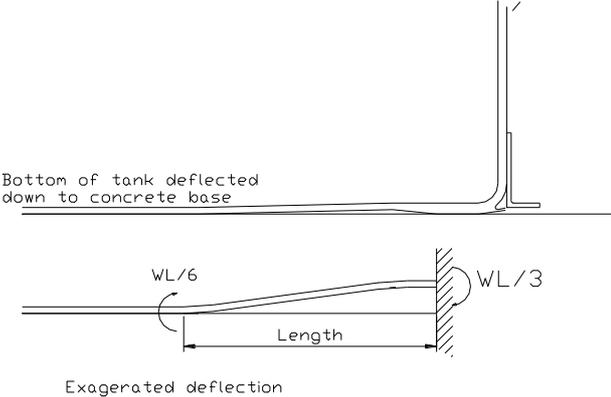
There is a step in the base of 10mm. See Fig 10 The base is sufficiently large that most of it’s area easily deflects to come into contact with the concrete support. However calculations have shown that around the periphery there is a ring 208mm wide that remains unsupported. The stress and the strain in this region were sufficiently high to have resulted in surface cracking.
